New York State Department of Transportation

Yellow Flag NB23U4W003

BIN: 1065318

Location: Span 103 Girder G1 Bearing at Pier 102

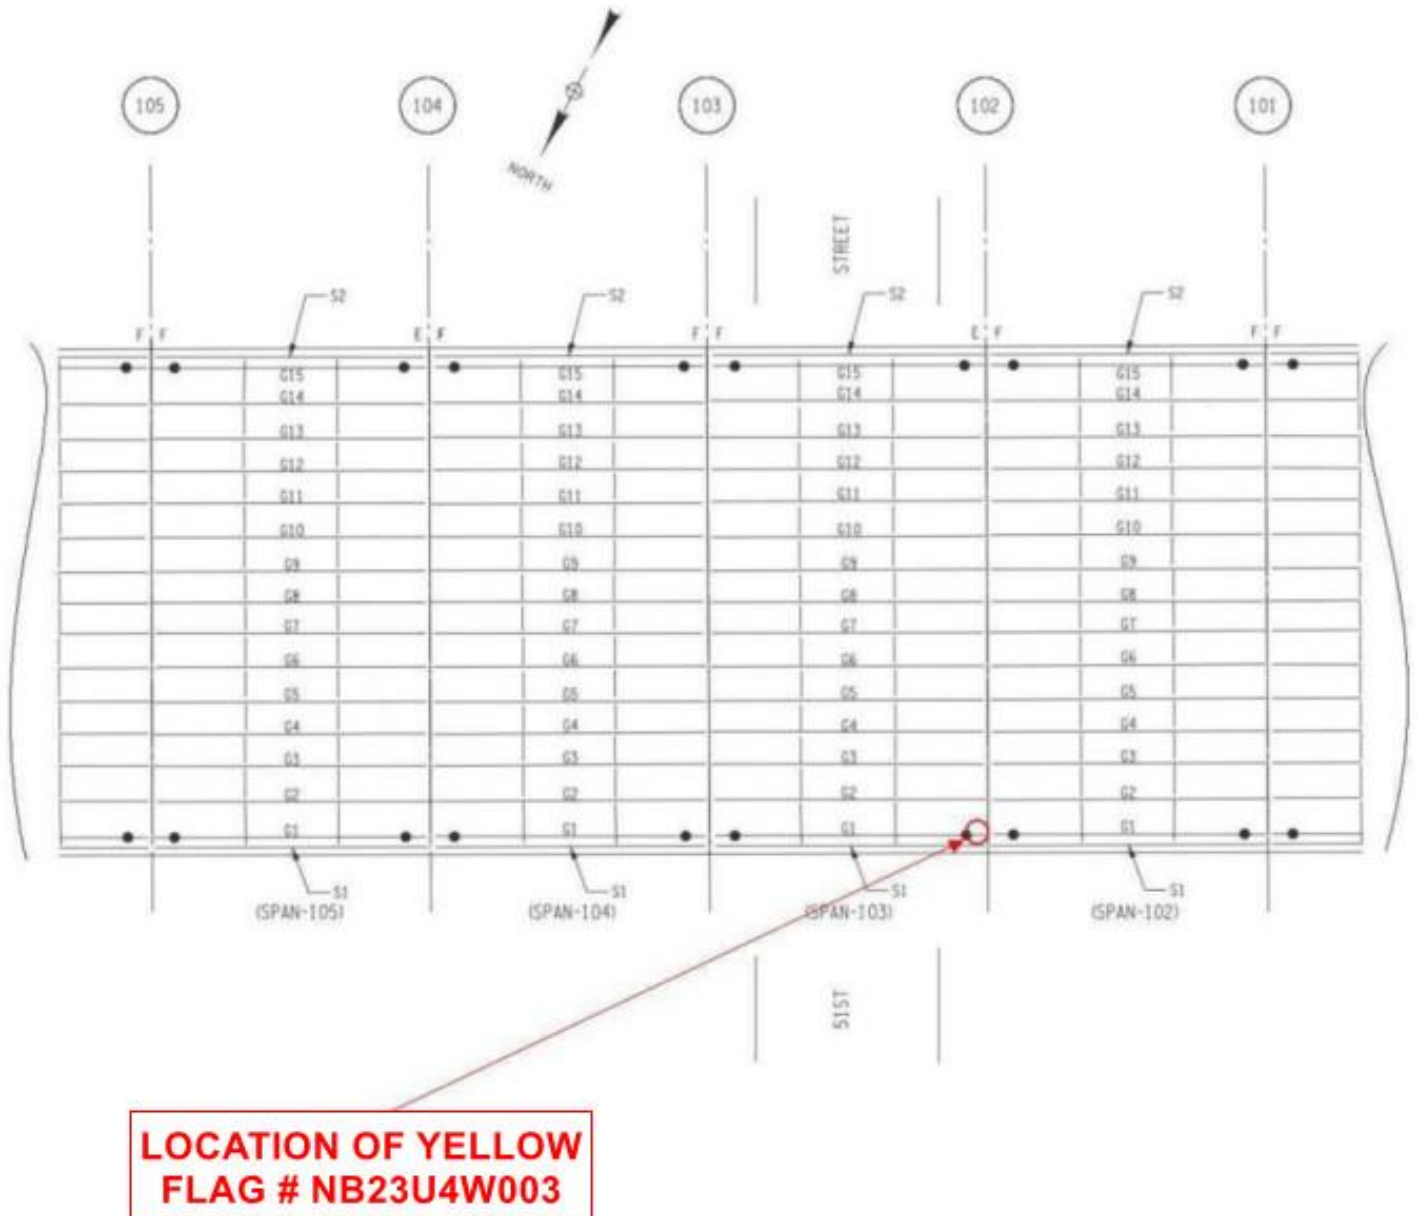
Photo Number: 1

**Attachment Description: BIN 1065318, Framing Plan, Spans 102-105**

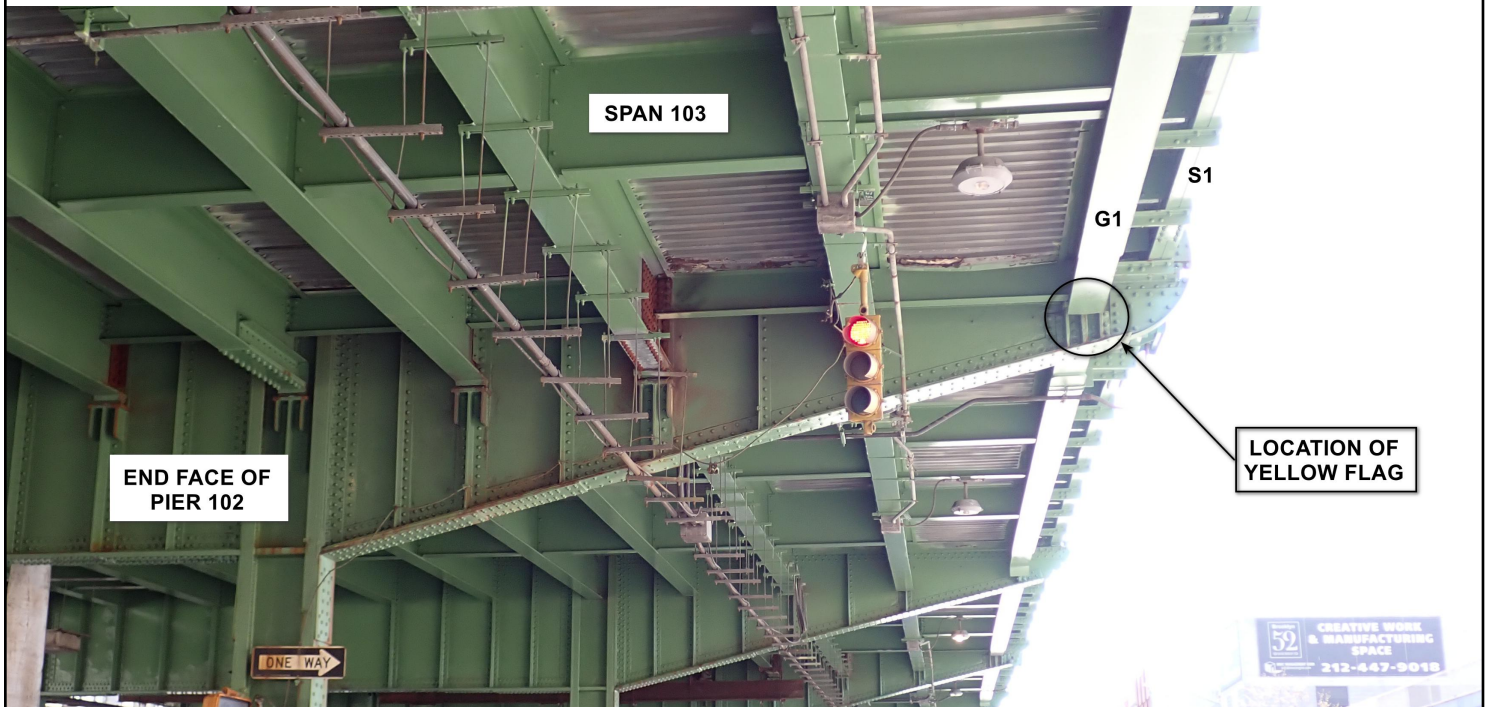
Photo Number: 2

The expansion bearing under Girder G1 on the Span 103 side of Pier 102 is not functioning as designed with the bearing plate overhanging the pedestal up to 1/2" (no change from the previous inspection). The sliding bearing plate is loose and moves when the inspection team hammers at the bearing (no change from previous inspection). The bearing plate is flush with the pedestal at the left side and overhanging the pedestal for 1/2" at the right side at 54 degree F (previously noted to be overhanging the pedestal for 1/2" at the right side at 55 degree F) (Photos 2 and 3). The front keeper plate at the bearing exhibits an 8" long broken weld at the bottom of the plate starting at the right side, with the remaining 6" of the weld intact and in good condition (no change from previous inspection). Due to the movement of the bearing plate, the top of the front keeper plate is bent towards the end side for 2" (no change from the previous inspection).

Attachment Description: General view of the flagged condition at bearing under Girder G1 on Span 103 side of Pier 102. Looking Begin.

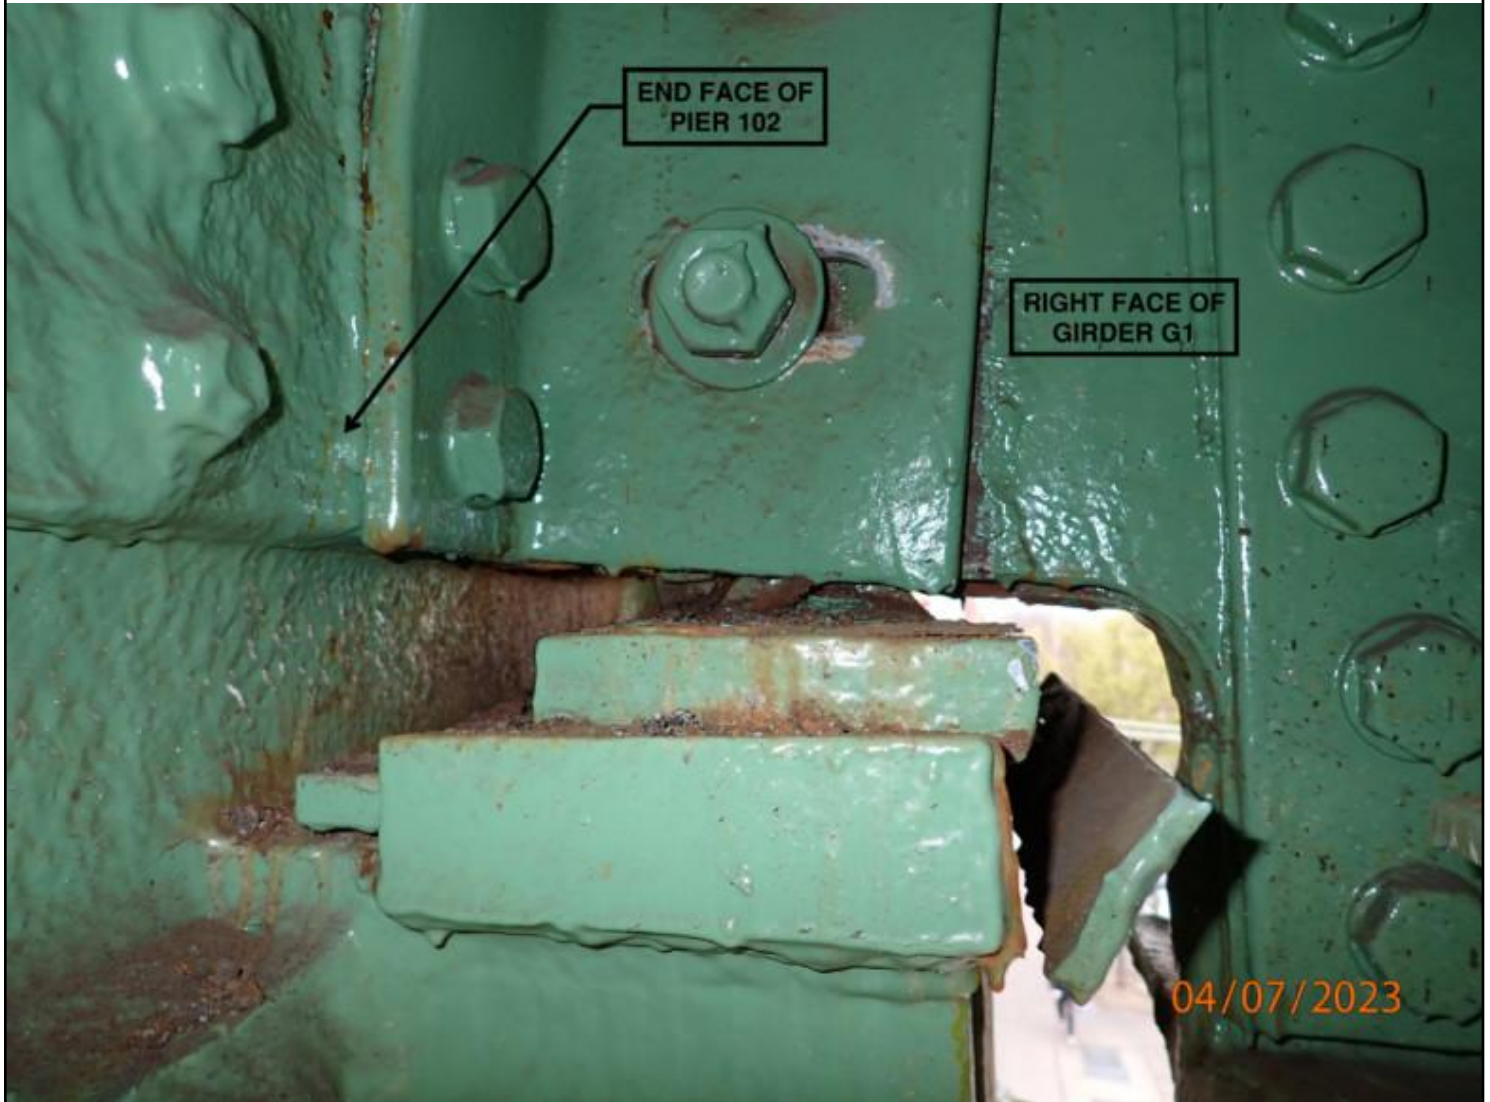
Photo Number: 3

Attachment Description: The right face of the bearing under Girder G1 on Span 103 side at Pier 102. The bearing plate is loose and overhangs the pedestal with the top of the keeper plate bent towards the end. Looking Left.

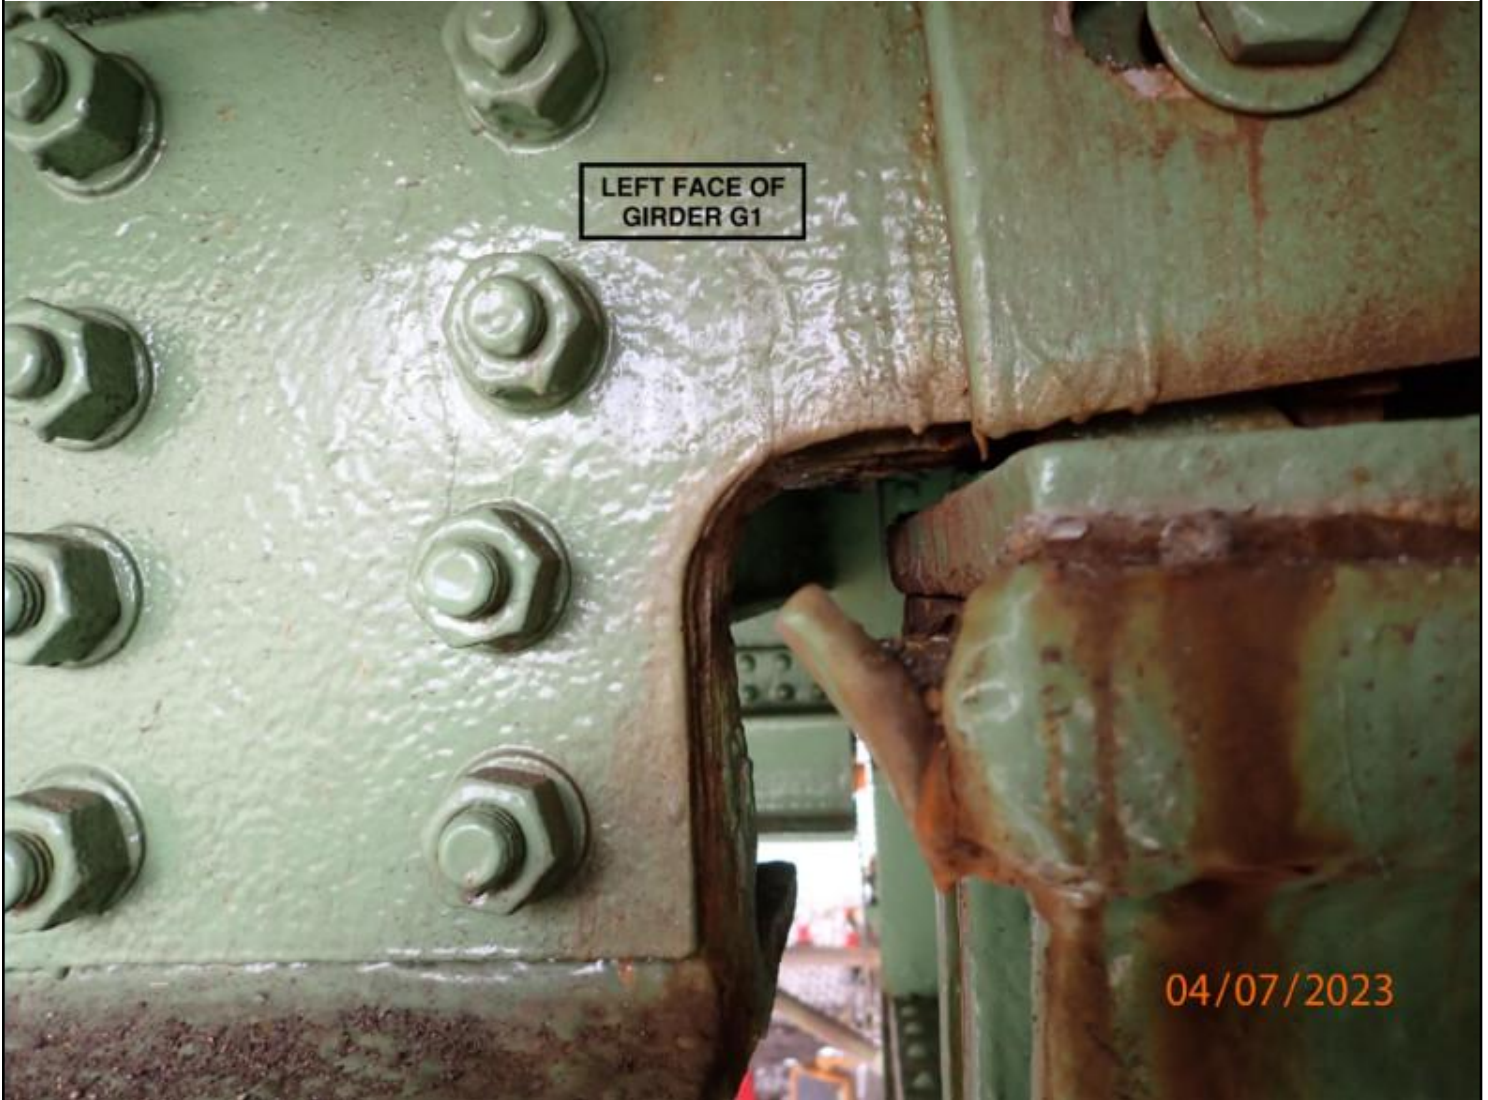
Photo Number: 4

Attachment Description: The left face of the bearing under Girder G1 on Span 103 side at Pier 102. The bearing plate is loose and is flush with the edge of the pedestal. The top of the front keeper plate is bent towards the end. Looking Right.

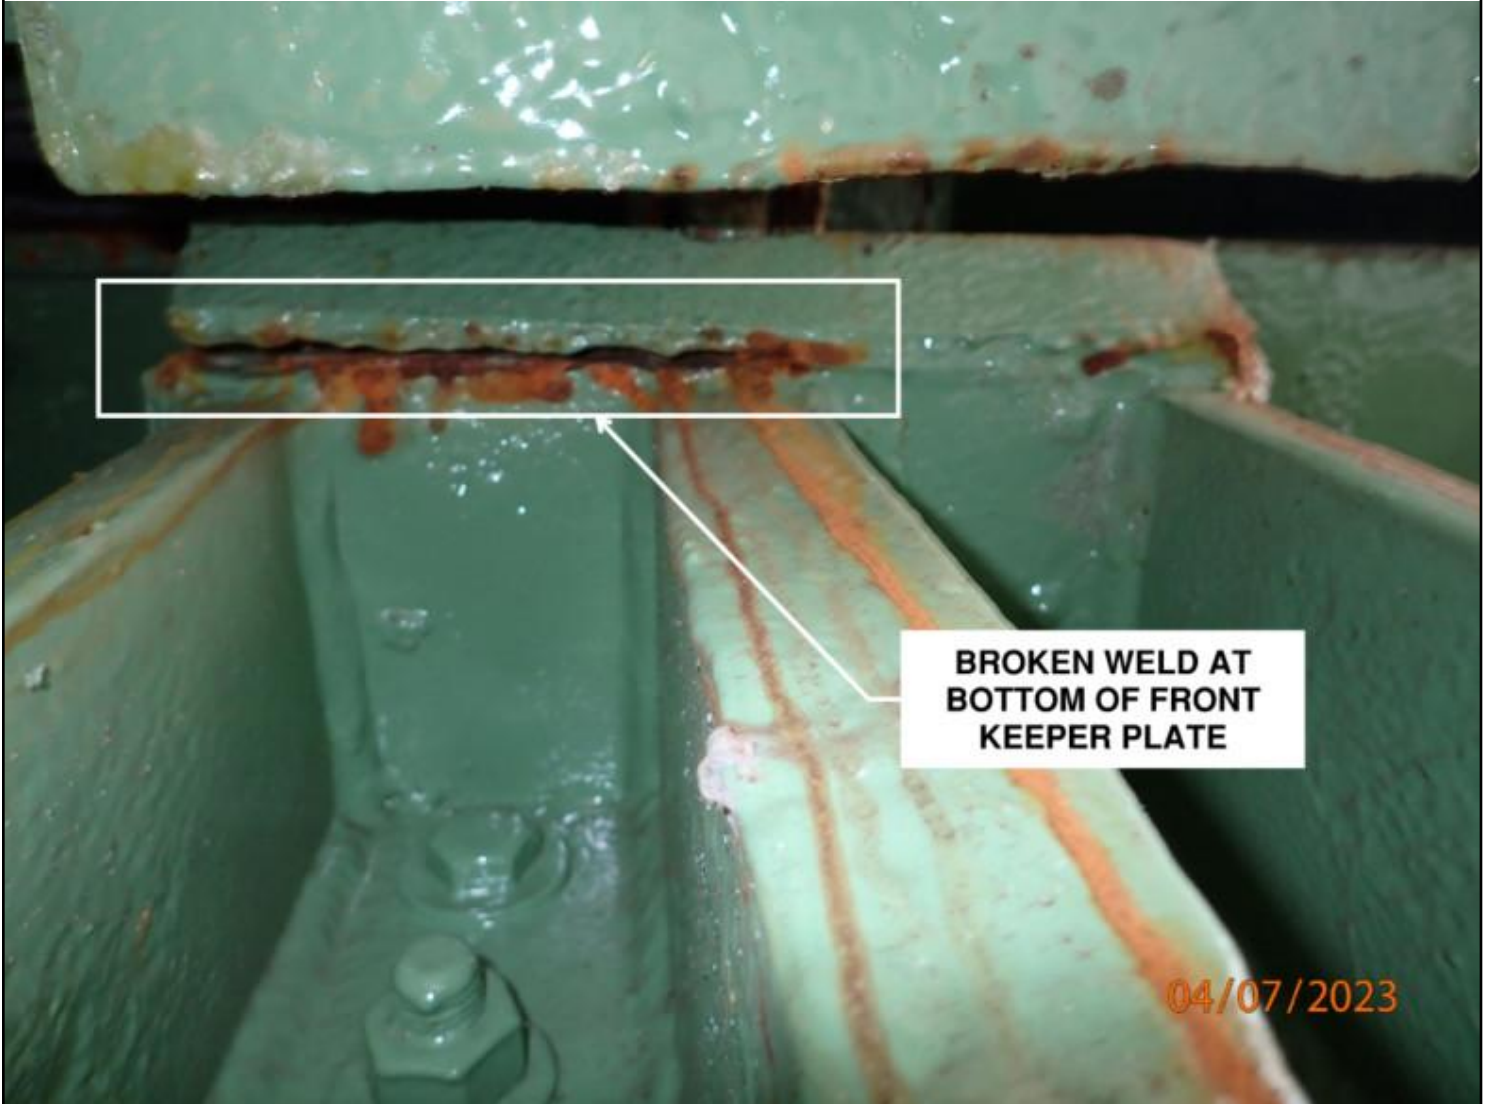
Photo Number: 5

Attachment Description: The bottom of the bearing under Girder G1 on Span 103 side at Pier 102. The bottom of the front keeper plate exhibits a broken weld starting at the right side. Looking Begin.

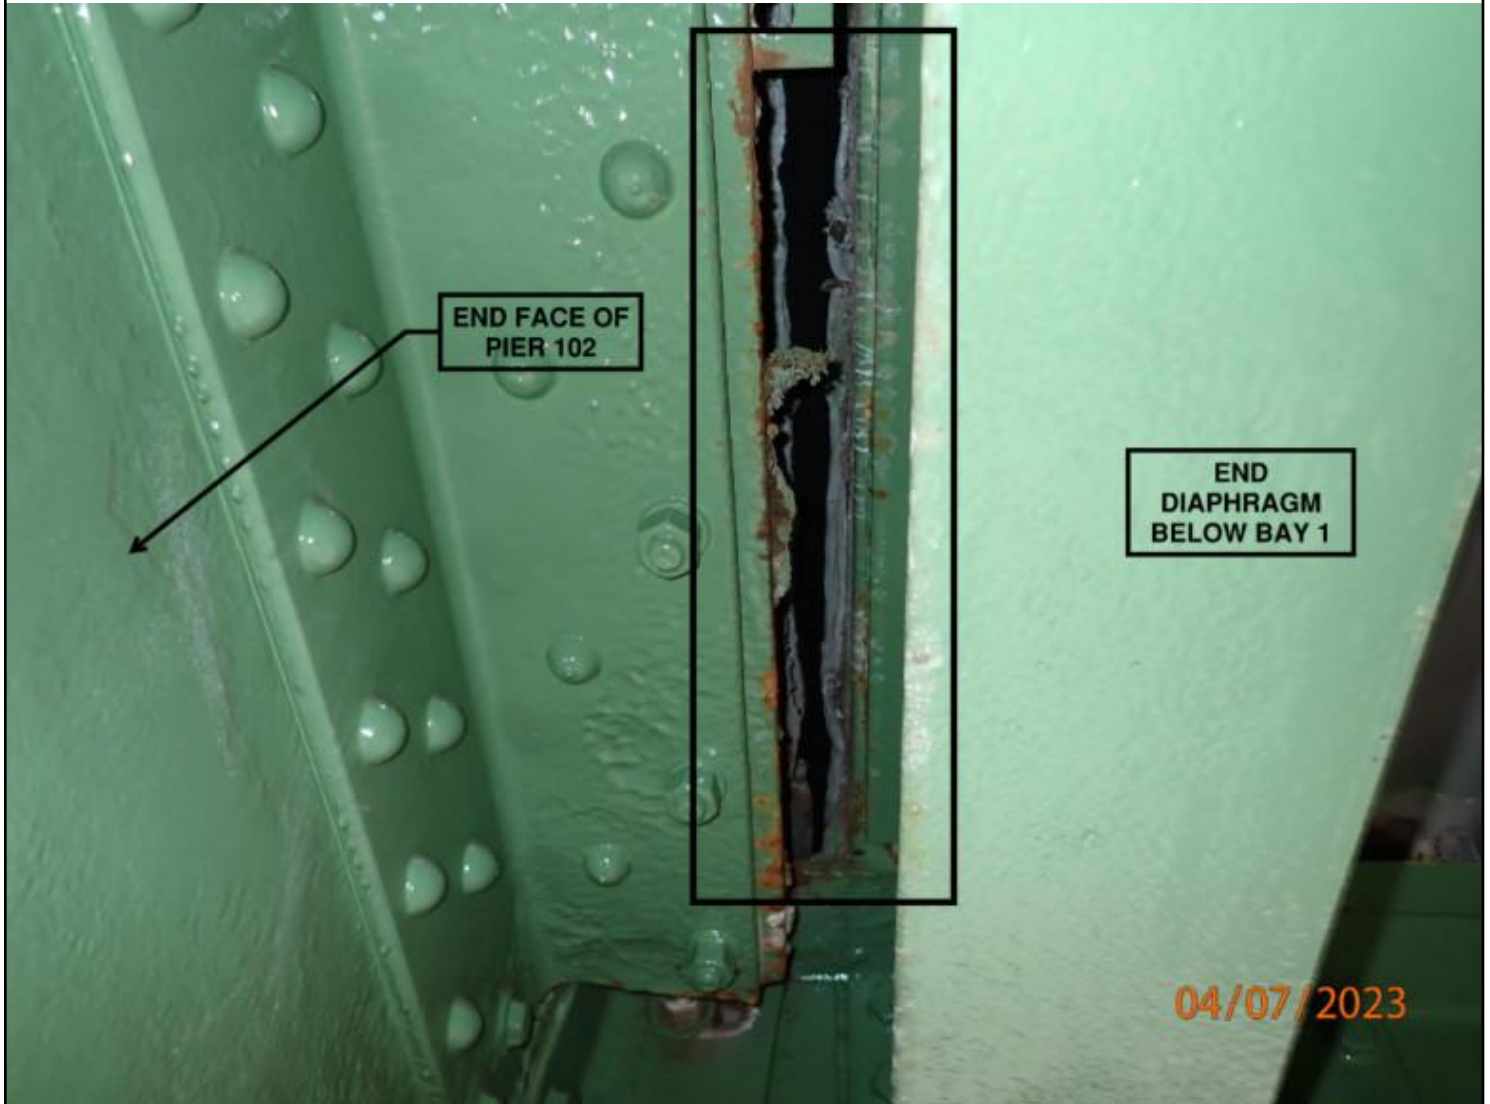
Photo Number: 6

- 2.The joint seal on top of the deck is replaced. Previously, it was reported missing with daylight visible thru the joint, below Bay 1 (Photo 5).
- 3.The end of Girder G1 at the bearing is in generally good condition and has been newly painted.

Attachment Description: The underside of the Pier 102 joint below Bay 1 on the end side of the pier. The joint on top of the deck has been replaced. Looking Left.
